Manhole Inspection Summary

Manhole # S35A1_007MH

Insp Date: **8/18/08 10:43 AM**

Location Address: **150 w dickman st**

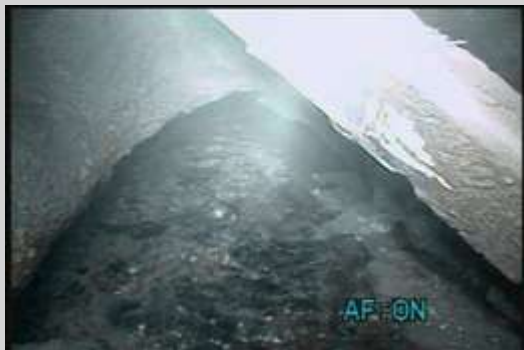
12 O'Clock Outflow

15 in. Circular Gravity Sewer
Pipe Out @ 12 O'Clock

Pipe Material: **Clay** ☐ Pipe Lined

Infiltration: **None** Pipe Seal Cond: **Unknown**
